APPRAISAL OF WORK DONE BY THE DIRECTORATE OF GEOLOGY AND MINING, DIMAPUR, NAGALAND DURING 2020-2021

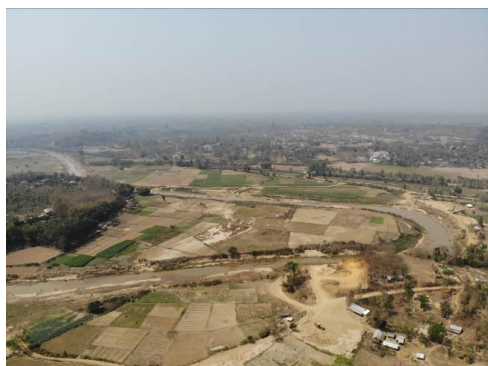
Pic: A view of Dhansiri River. Overflowing of Dhansiri River during monsoon is one of major cause of inundation in low lying areas.

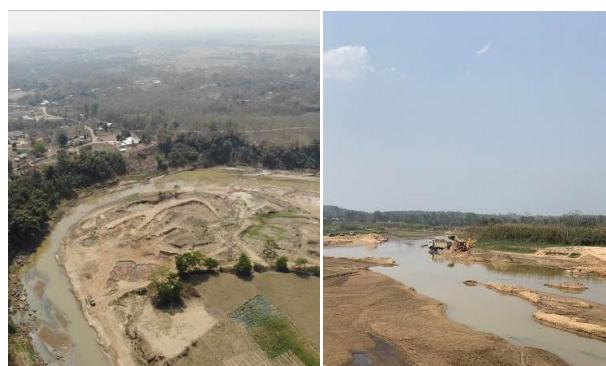
Pic: Unregulated sand mining altering river course and eroding banks causing flooding in low lying areas.

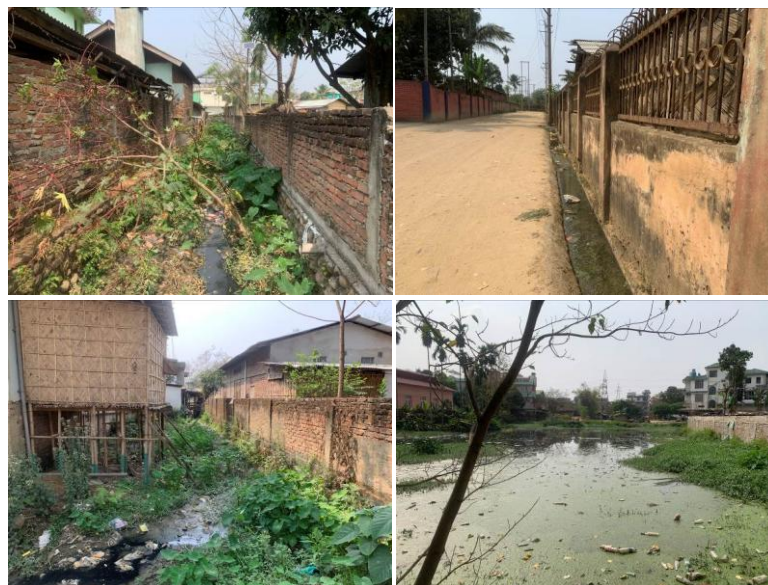
Pics: Clogged drains, absences of proper drainage system, encroachment of natural drainage and water bodies is contributing to inundation in urban areas.
